# Cause and Measures of Transverse Corner Crack in Hull Structural V-Containing Steel CC Slabs

Shougang Iron and Steel Group Corp.

**Abstract:** The reasons of transverse corner crack in hull structural steel CC (continuous casting) slab have been analyzed in this paper. The influence of steel-making, continuous casting technics and micro alloy element has been discussed. The improving measures are put forward and better effects have been obtained.

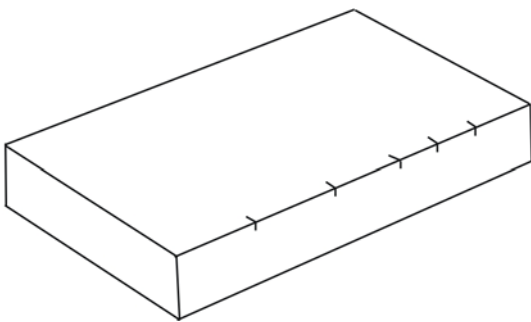
Fig. 1 The sketch of transverse corner cracks.

The character of transverse corner crack was showed as figure 1 (sketch). The transverse corner crack of the slab in the production was showed as figure 2. The transverse corner crack in Shougang hull structural slab often happened at inner arc of the slab, also at the deep of oscillation mark. The cracks took place at the corner and extended to the broad and narrow face. The length of the crack was about  $2\sim 10\text{mm}$ , and the depth of it was about  $2\sim 5\text{mm}$ .

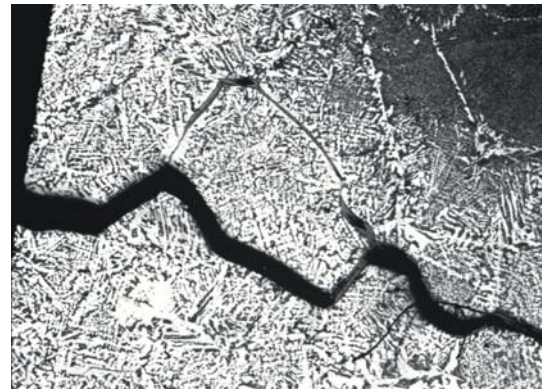
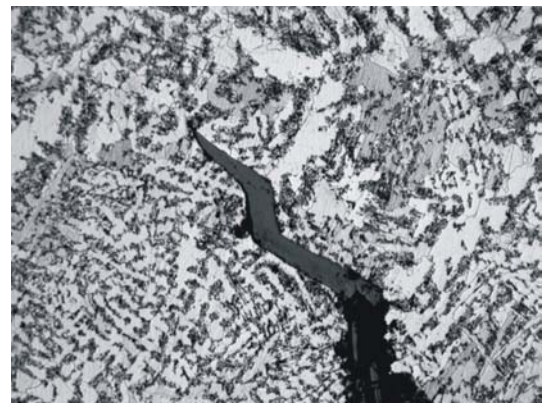
Fig. 2 The transverse corner cracks of the slab.

Figure 2 is the metallograph of the transverse corner crack in Shougang hull structural slab. We can see from it that around the crack there is no visible decarburizing and oxidizing, and the crack expands along the boundary of austenite grain.

(a) The crack surface end ( $\times 25$ )

(b) The crack inner end ( $\times 100$ )

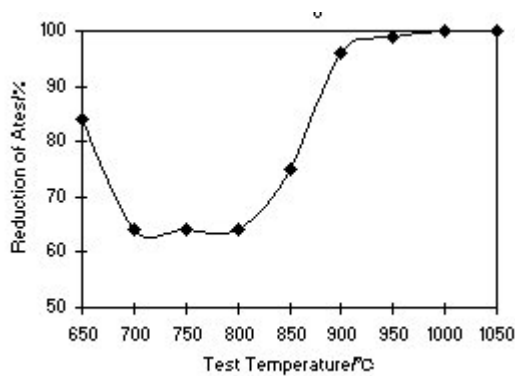
Fig.3 Reduction of area changed by the test temperature of D36 grade

Compared with HSLA simple steel, No 3 fragile temperature province of Shougang microalloyed hull structural steel of 355MPa grade will be enlarged for the precipitation of the carbide and the nitride, which upper limit value increases from 850°C to 920~930°C and which lower limit value decreases from 720°C to 650°C. All those will magnify the difficulty of avoiding straightening during No 3 fragile temperature provinces. The conclusion has been testified in our thermal simulation test and showed in figure 3 followed.

Seen from the measured temperature of the slabs in № 2 steel making plant, straightening temperature is usually 880~900°C. It is the main reason that results in the transverse corner crack happened not keeping away from № 3 fragile temperature province in its entirety. So some measures followed should be taken:

- (1) To ensure the casting liquid steel in low degree of superheat that is less than 25°C.
- (2) To maintain the stability of the casting speed and the fluid level of the crystallizer.
- (3) To decrease the cooling intensity by lessening the cooling water in № 2 cooling

Applied these measures above, the asymmetry of the temperature in the slab has been bettered and the measured temperature of straightening the slab has been increased to 930~950°C. The probability of occurrence that the transverse corner cracks are generated in the slab has decreased consumedly from 11.80% down to less than 0.1%, which betters evidently the quality of the slab and reduces the cost of the industrial production.
